The Mumma Barn

# ANTIETAM

# Historic Structure Report

April 2000

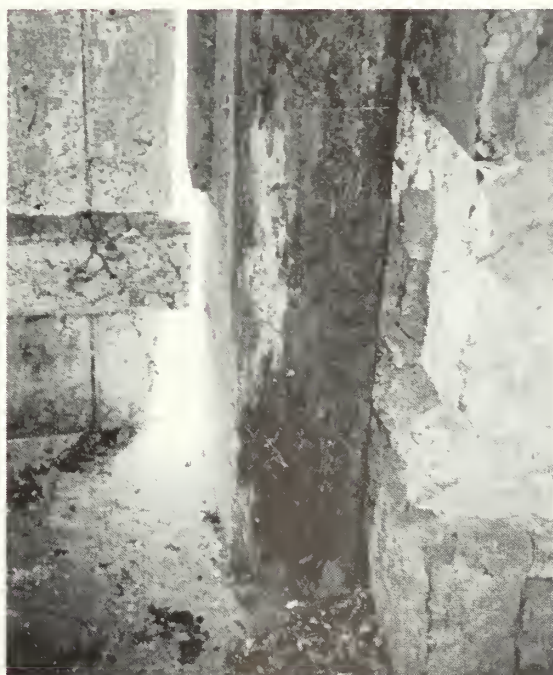
Figure 192: Wood door frame of split door on the southeast elevation. Note insect attack.

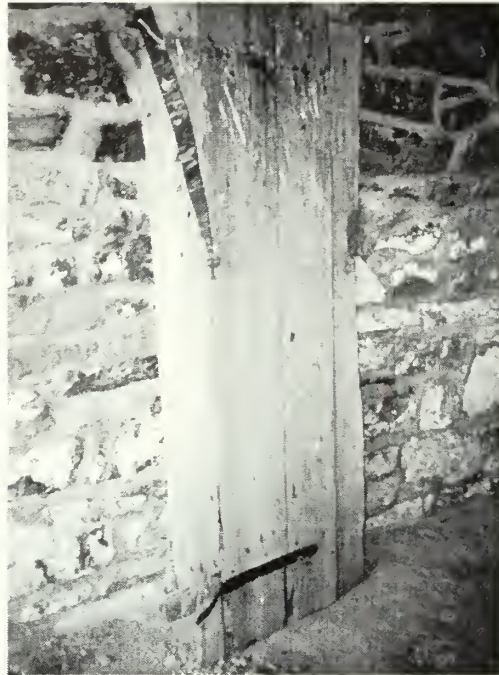
The condition of the doors throughout the structure is fair to poor: all are wood; many are missing altogether, have portions of the door missing, are racked, are out of plumb, or have been substantially rebuilt. Repairs have been made on the large doors at the wagon ramp entrance (the large door on the northeast side was rebuilt)(Figs.181-185), and portions of the winnowing doors that hover over the barnyard on the southeast elevation are not original (Fig.186). The six split doors and the double-swinging doors that lead from the ground level to the barnyard are in a state of disrepair (Figs.187-190). Some original hardware exists, which may be reused (Fig. 191). All doors are framed in wood and most frames are in fair condition, with several areas of insect damage where historic material will have to be replaced (Fig.192). Locks do not exist on any doors (with the exception of a pad lock on the west granary), so there is no way to secure the building (Fig. 193).

Figure 193: Original door to the dairy area (at north corner of barn off its hinges and in a state of disrepair).

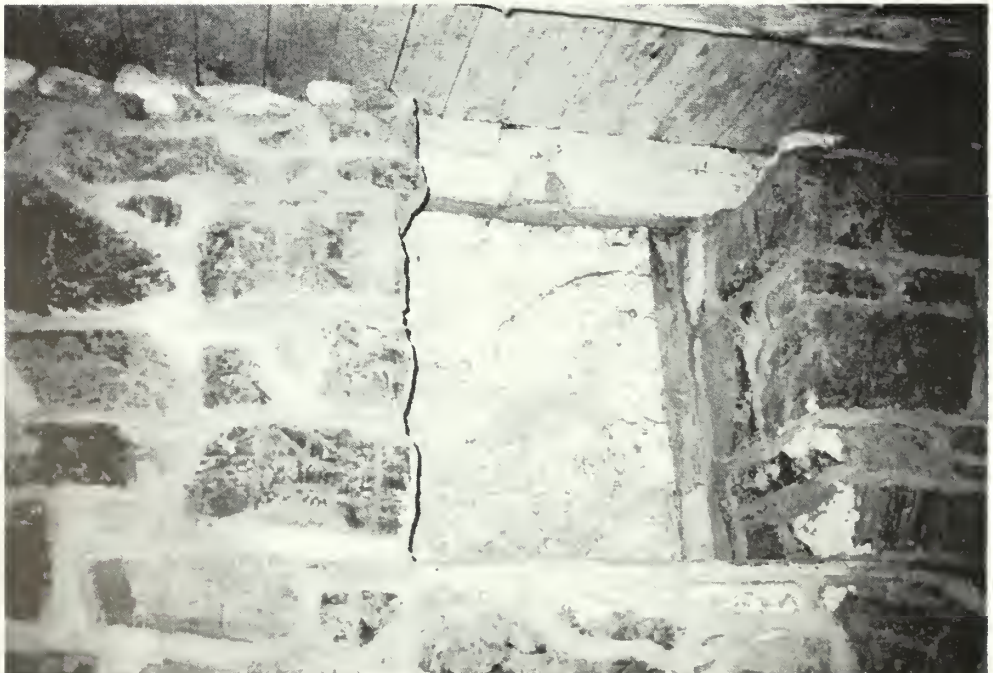
Figure 194: A typical opening (at the northeast elevation) covered over with sheet metal.

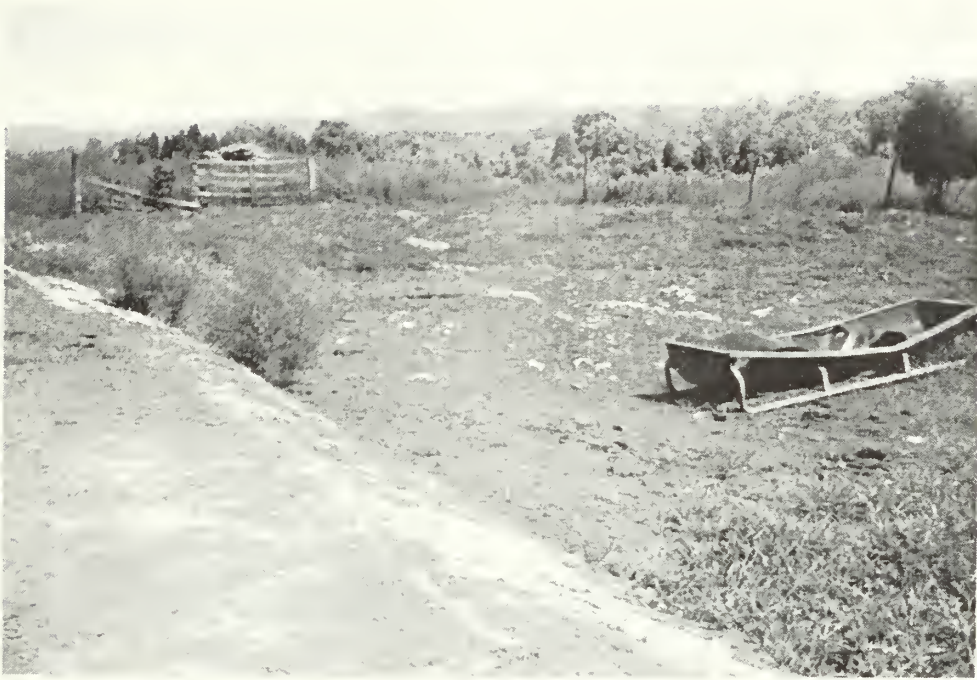
Figure 199: Barnyard looking east.

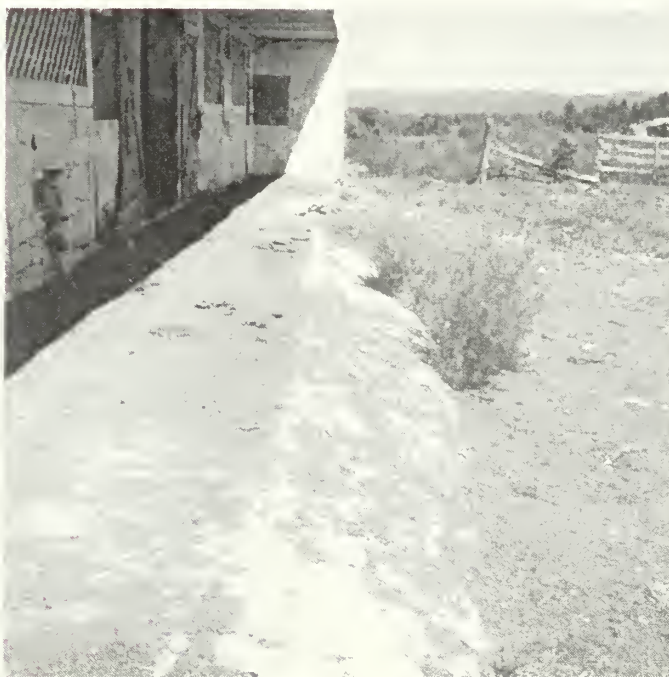
Figure 200: Concrete path that runs the length of the barn (front elevation). Note the significant drop from the path to the barnyard. This is due to animal traffic over the years.

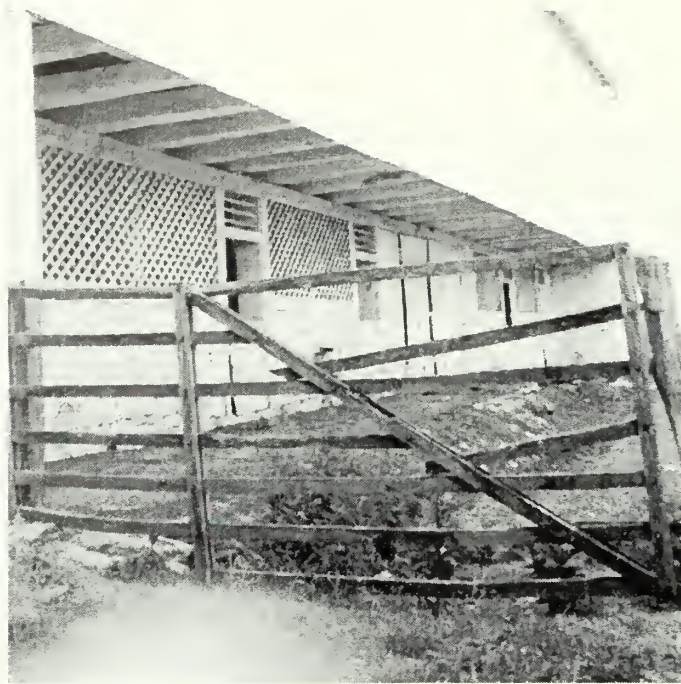
National Park Service, National Capital Region, List of Classified Structures (LCS).<sup>75</sup> It was repaired recently and is in good condition (Appendix K, Fig. 69, and Fig. 186). Defining the barnyard on the southeast side is barbed wire and scattered fieldstone, and on the northeast side there is a deteriorated wood fence. Broken nonhistoric wooden gates allow access to the yard from the southwest and northeast (Fig. 201).

Figure 201: Gate at the south side of the barn is non-original and in a state of disrepair..

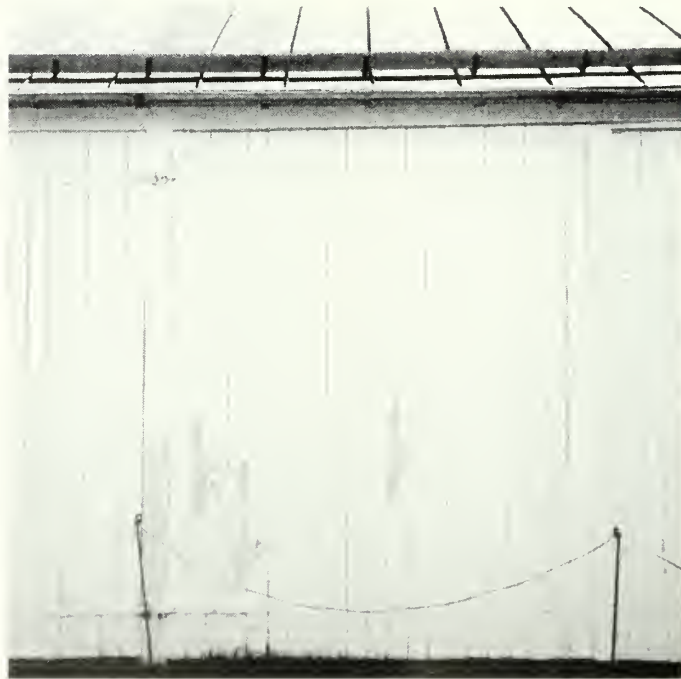
Records indicate that the exterior of the barn was last painted in 1992, with two coats of gloss oil, exterior house and trim paint, in "brilliant white".<sup>78</sup> Today it needs to be repainted once again, as it is peeling in several areas. It has been painted numerous times over the years and after many reapplications, adhesion is fair (Fig. 202).

Figure 202: Typical peeling paint on the surface of the barn (northwest elevation).

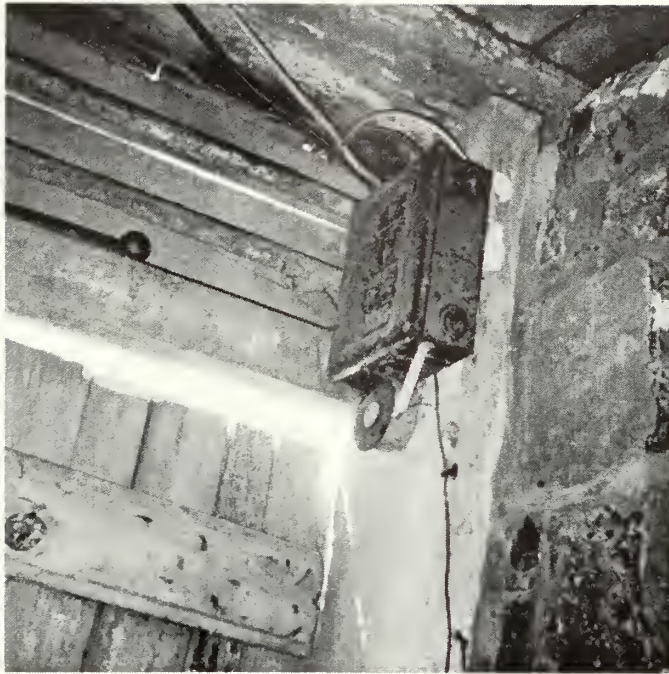
Electrical service was added to the barn in 1937 and a service panel still exists at the west corner of the ground level at the door frame (Fig. 203). There is currently no power to the barn. Even if power still existed, it would not meet today's requirements in terms of amperage and electrical codes.

Figure 203: Abandoned electrical box at entrance to ground level (west corner)

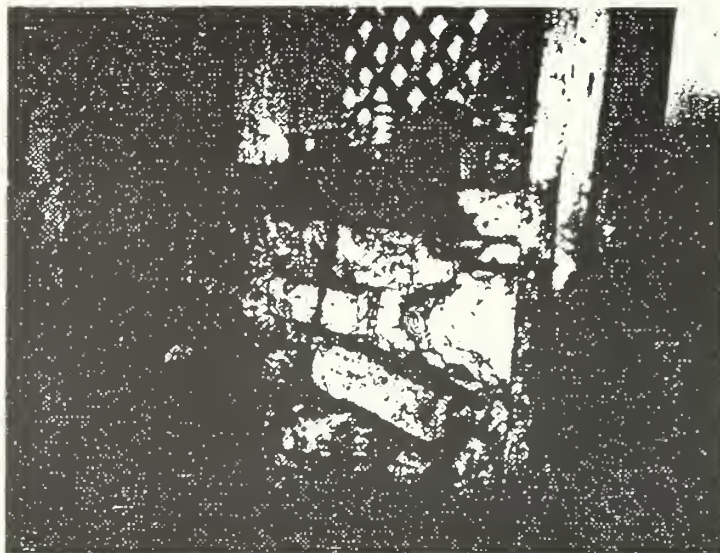
Bldg. 43 - Barn Munna Farm  
Item 3 - Area of missing foundation  
wall stones

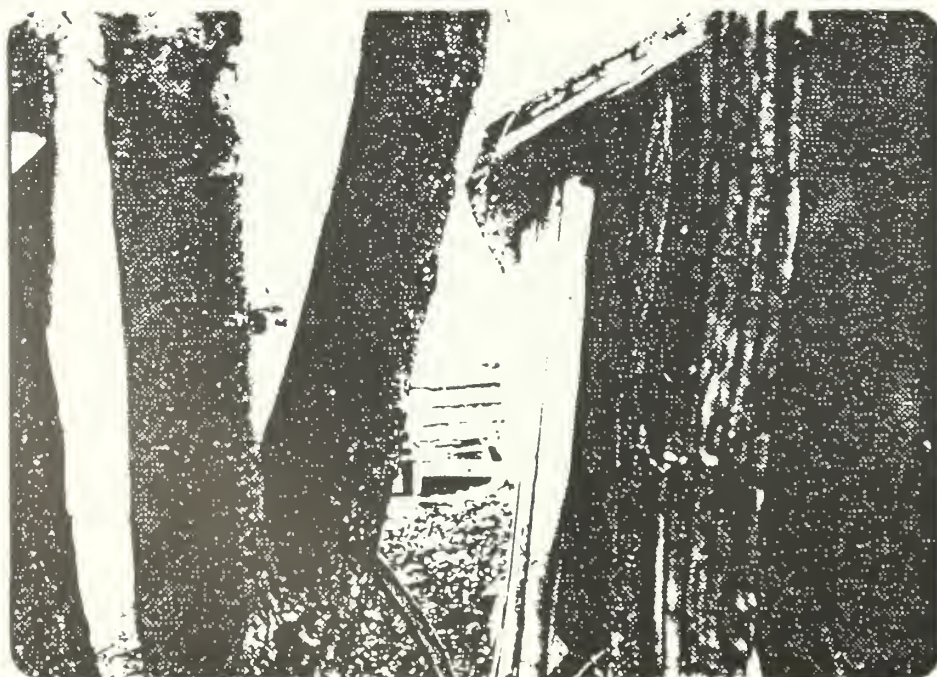
Bldg. 43 -  
Item 4 - Implement shed - west view

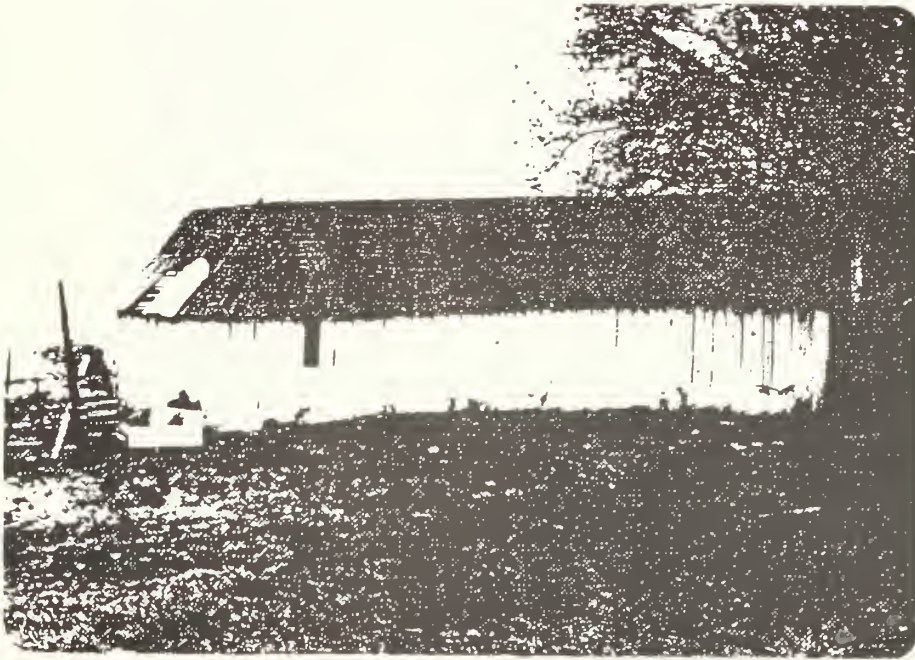
Bldg. 43 - Munma Farm  
Item 4 - Implement shed - north view

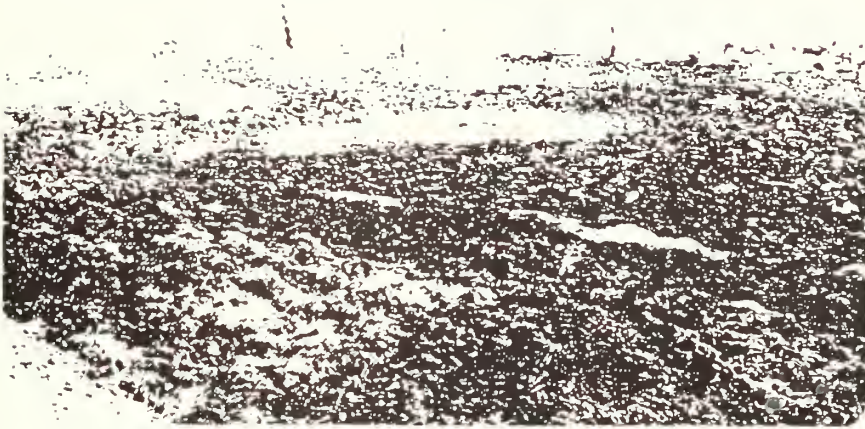
Bldg. 43 - Mumma Barnyard  
Item 10 - Animal waste and improper  
drainage - stone outcropping

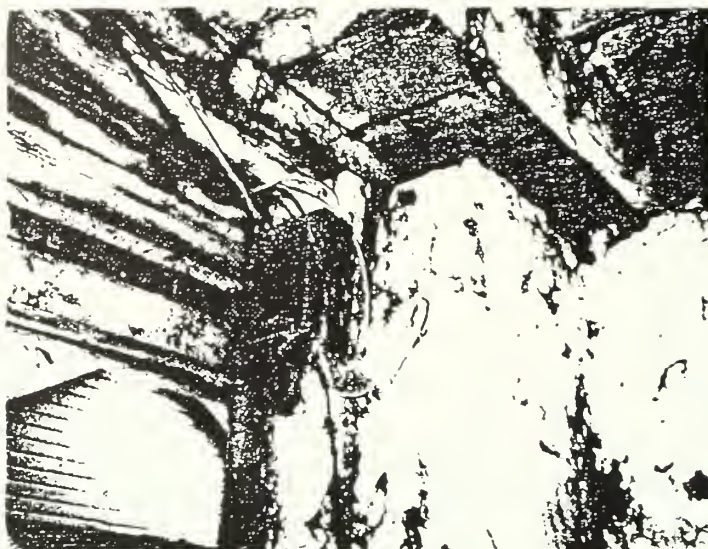
Bldg 43 - Mumma Barn  
Item 8 - Electrical Service Panel
